**SAS Superstructure**

Location: 04-SF-80-13.2 / 13.9

Daily Diary Report by Bid Item

Diary #: 174 Const Calendar Day: 793 Date: 10-Nov-2011 Thursday

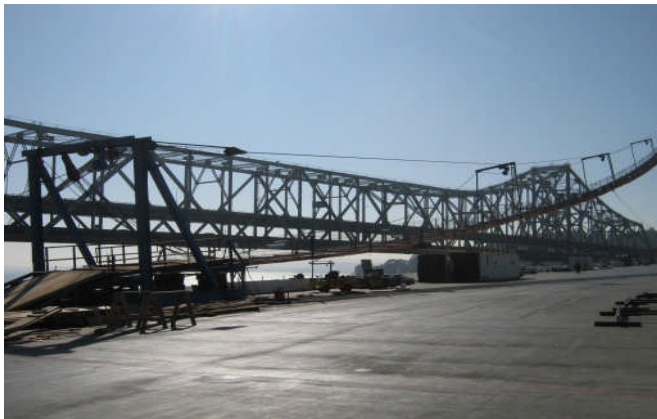
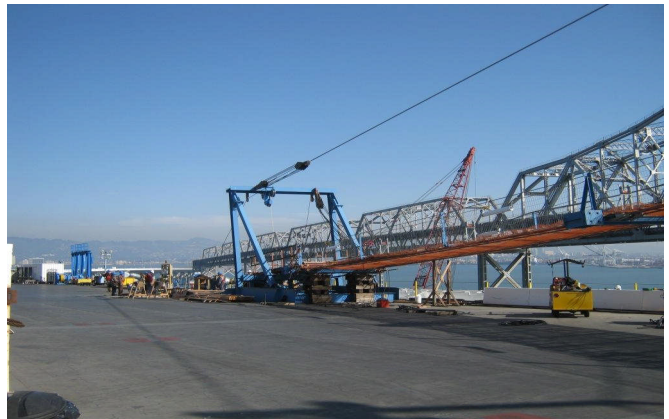
While I was walking under the South side of the main span catwalk at 1:10pm, I noticed that the catwalk above me suddenly started to sway and rock significantly. The cause was that the winch that supports one of the tramway cables at OBG Lift 12E had slipped. This tramway cable went completely slack (see attached photos), which caused that side of the catwalk to drop and start to rock. Nobody was on the catwalk at the time, and nobody near the winch was injured. I tried to inquire with the ABF personnel on site as to the cause of the winch failure, but everyone was busy trying to correct the problem, and was not available to discuss it.

Slack tramway cable on South side of main span catwalk
